Hunters Point Naval Shipyard BCT Meeting

Presentation Overview

Hunters Point Naval Shipyard BCT Meeting - May 29, 2013

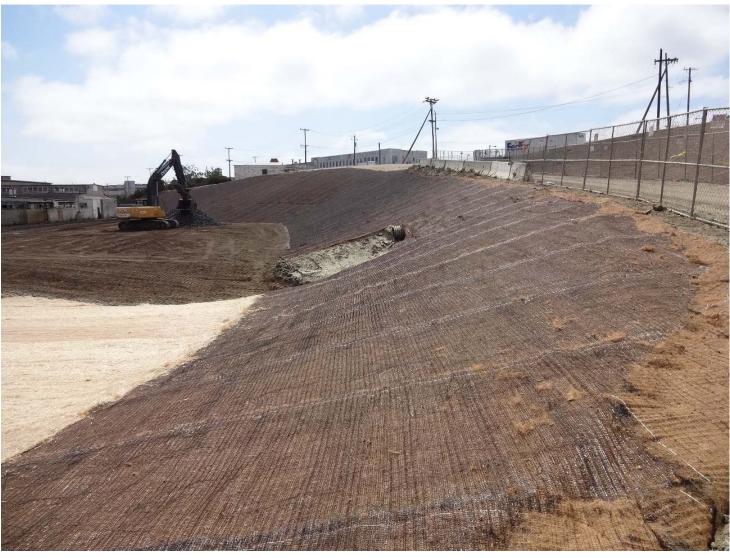
RA Photos Completed CTRM/Erosion Control Fabric Installation

- Installed ~16,800 tons of 2-foot soil cover (100% complete)
- Installed CTRM and erosion control fabric over all slopes (100% complete)
- Hydroseeded and hydromulched 3.5 acres of cover (100% complete)
- Installed irrigation system for vegetation establishment (100% complete)

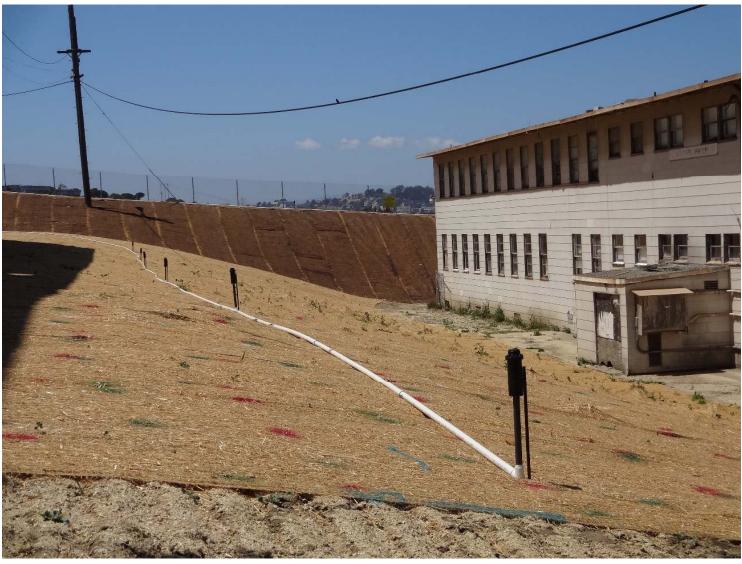
RA Photos Completed Installation of Irrigation System

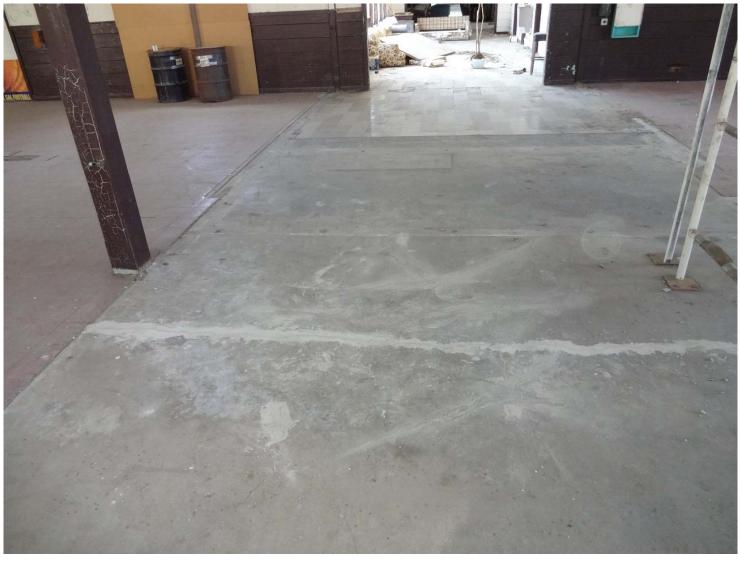
RA Photos Completed Building Foundation Repairs

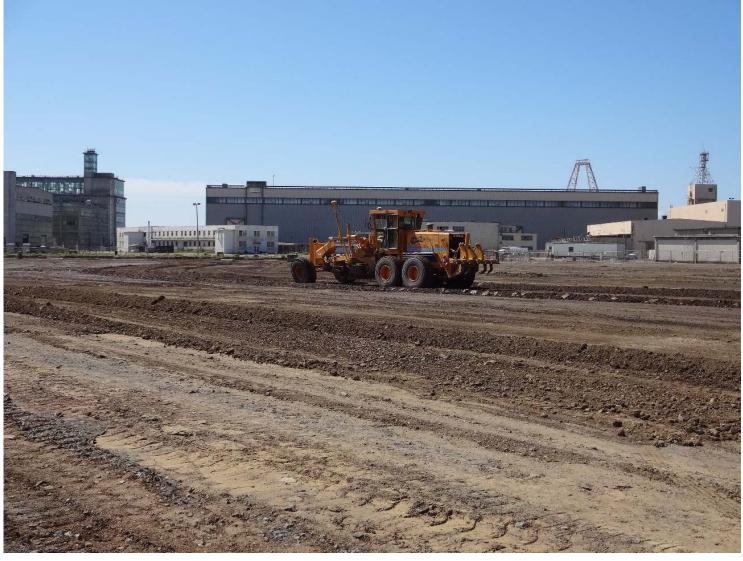
RA Photos Began Site Grading with GPS-Guided Motorized Graders

- Relocated all soil, sediment, and debris piles outside Parcel B to allow for site grading
- Established survey control points across site to guide grading activities
- Began site grading using GPS-guided motorized graders (35% complete)

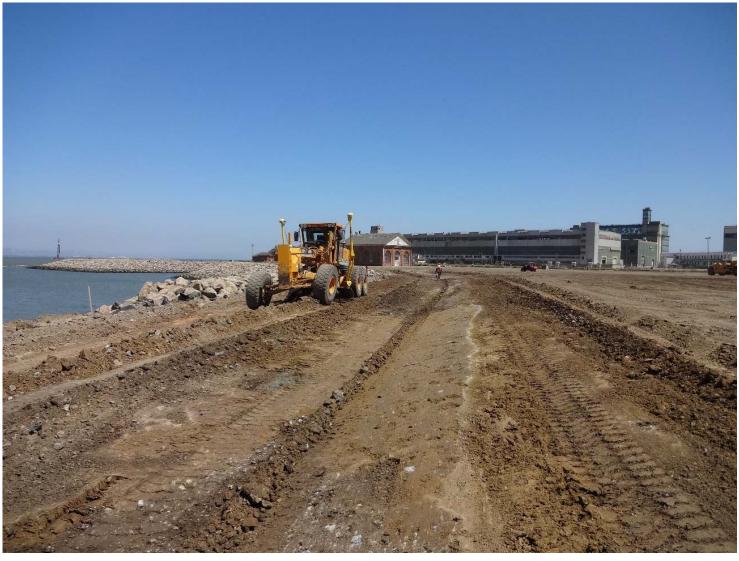
RA Photos Cutting New Drainage Swale Along Revetment Crest

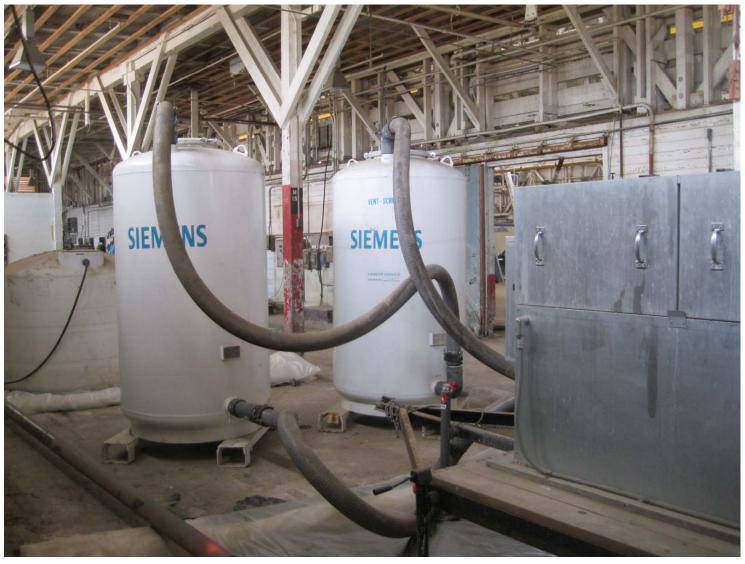
RA Photos SVE System Commissioning Completed – Ready for Operation

- Conducted Triad meeting to establish methodology for SVVE system operation and monitoring
- Received concurrence on approach from the BCT
- Completed SVE system commissioning, including:
 - Testing of all mechanical and electrical components
 - Leak testing of all conveyance systems
 - Startup testing
- Navy ROICC and CSO oversaw all commissioning tests and approved system startup
- System operations plan, including commissioning test results, will be submitted to the BCT within the next two weeks and system operation will commence
